***Hi-Impact 8000 brand Fire-shield  
Gypsum Wallboard  
5/8" Tapered Edge Type X Core***

***Test #2  
Fire inside the wall***

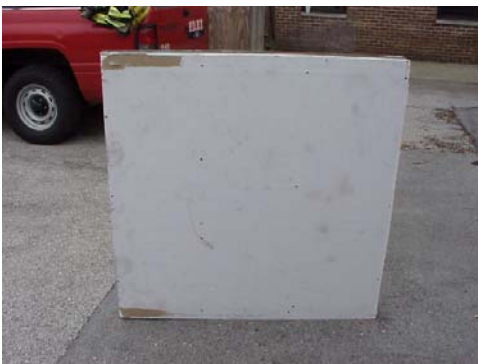
4' x 4' wall with metal stud framing and Hi-Impact 8000 wallboard mounted to both sides of the wall.

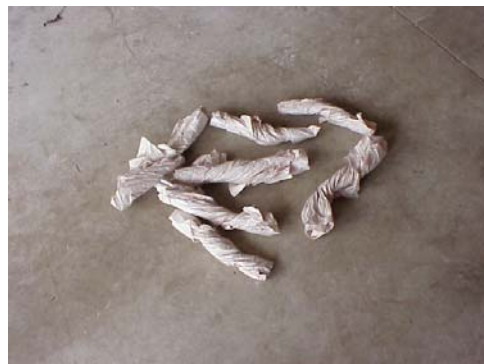
Approximately 4 pieces of white packing paper were ignited inside the wall to simulate burning materials that have dropped into the wall during a structure fire.

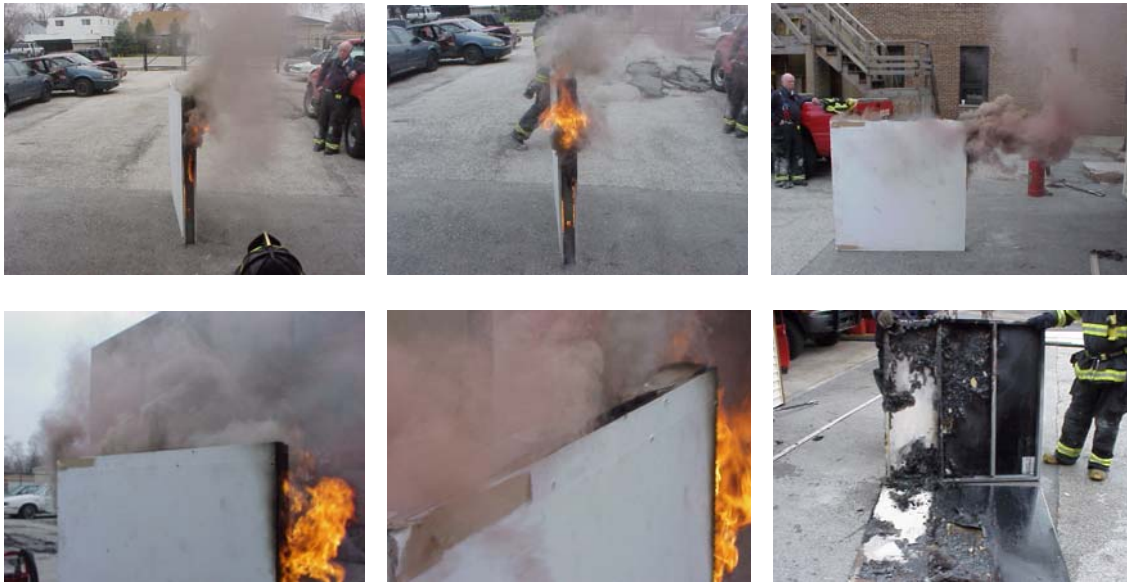
After extinguishment, one side of the test wall was removed to evaluate the amount of fire spread inside the wall. The fire completely consumed 1 full bay of the Lexan backing between the stud spaces where the fire was started. The fire then traveled through the pipe chases in the stud to the next bay, consuming the top ½ of the 2<sup>nd</sup> stud space. It was noted that some of the Lexan that had melted down was starting to ignite the bottom of the wall in the 2<sup>nd</sup> stud space. The 3<sup>rd</sup> bay in the test wall suffered very minor damage if any at all.

In conclusion, it was demonstrated that the Lexan backing contributed to the fire spread within the wall. The Lexan backing also created a heavy and multiple colored smoke condition during the burn phase of the test.
